## Subject Syphon Pump Conversion

The answer to all these problems is a Syphon Pump Conversion.

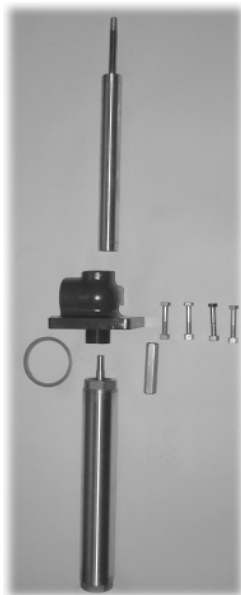
Instead of trying to resurrect the old pump, it can be converted into a modern Syphon Pump.

This involves changing the Top Cap, replacing the internal components with an off-the-shelf Flush Cap Pump, fitting a new Differential Compensator, and plugging the old outlet.

The Syphon Pump Conversion has a single seal; below the (new) Top Cap.

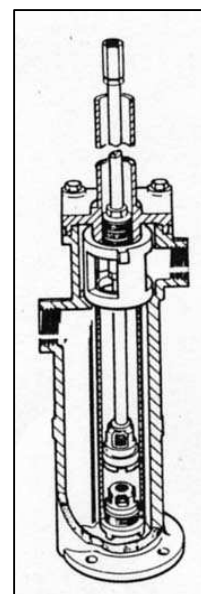
One problem with the old style Syphon Pump (shown at right) was the seal below the Cast Iron Collar. This seal is often forgotten. If this seal doesn't work then the water will be circulated from the delivery side of the Plunger back to the suction side. The Seal will fail when the leather is too old or the casting is badly corroded.

A great frustration with old Syphon Pumps is getting them to pump properly. The main reason for this frustration is almost certainly to do with the fact that there are two seals to contend with. The top seal is between the main (cast iron) body of the pump and the Top Cap. The bottom seal is below the Cast Iron Cylinder Collar. This one is often not looked at, and it is a critical seal – if this seal leaks the pump will circulate water back into its own inlet.

The next advantage is the elimination of one of the leather seals – especially the bottom seal (below the Cast Iron Cylinder Collar).
